**Flood Control Project Maintenance
Levee Inspections**

Fall 2018 Levee Maintenance Deficiency Summary Report

Sacramento River Basin

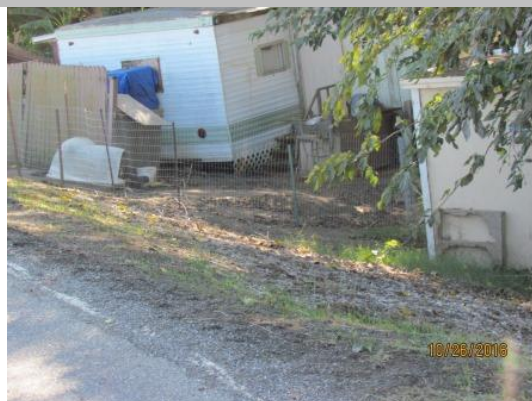
Photo 1 of 1 : FA_2018_ST0003_264_3_20180905_00003.jpg

View of the trailers and building on the waterside.

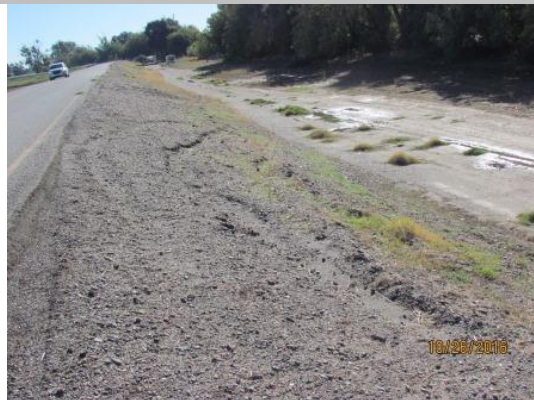
Photo 1 of 1 : FA_2018_ST0003_264_81_20180905_00019.jpg

LM Start	0.42	Rating **	M	Issue No.	81
LM End	0.42	Issue Type +	Ma	Location *	WS
Category	Earthen Levee			GPS Latitude/Longitude	
				Start	End
Item	Slope Stability			39.196483 °	39.196483 °
				-121.942228 °	-121.942228 °
DWR ID	DWR_ST0003_01_f_2016_81				
Comment Code					
S3 : Repair the levee slope damaged by vehicle traffic and prevent access where possible.					
Inspector Comment

View of the ruts along the waterside slope.

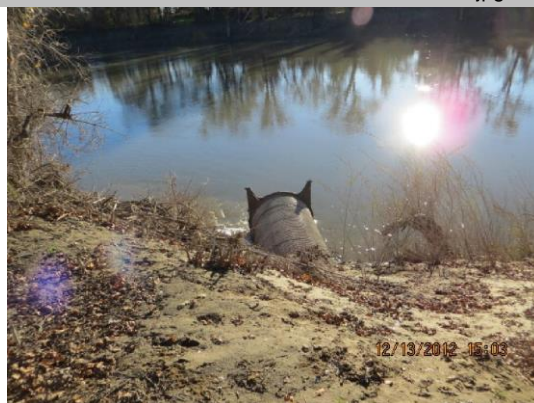
Photo 1 of 3 : UCIP_FA_2018_51650_46962.jpg

Comment Code						
Inspector Comment						
FS_ID:51650 DS_ID:17307 EP_NO: 9534 Repair Type: No Action Needed Crossing Status: Found UCIP Comments: 10/27/2017 This structure is inspected annually under the Structure and Channel Summer Inspection (part of the Levee Inspection Program) conducted by the DWR Flood Project Integrity and Inspection Branch (FPIIB). (DWR UCIP - O. Magana) 4/24/2017 Both sides of crossing were underwater during site visit. Will need to revisit after water levels drop. (DWR Sutter Yard-AFreitag) 11/7/2016 Crossing appears to be in good condition. (DWR Sutter Yard- AFreitag)6/6/2016 Crossing appears to be in good condition.4/6/2015 Good Condition. No issues. Semi circle CMP half riser in inlet structure on LS. Inlet opeing has no trash rack, this may cause safety issue.6/30/2014 Same as last inspection.12/30/2013 Same as last inspection.7/29/2013 Same as last inspection. FIELD_STRUCT_DESC: [Butte Slough Drainage Structure] 78-inch drainage pipe of an unknown material through the levee, 3 feet below the crown. Flap gate on the waterside (WS). Corrugated metal pipe (CMP) half riser (in a semi-circle configuration) in the inlet structure on the landside (LS). (78-inch pipe [HLM 0.44] authorized under Automatic Board Order (ABO) issued as Permit No. 9534, 1974 - Caleta). [Additional Reference(s): DWR Levee Log, 2002. USACE Sacramento O&M Manual 136, March 1960 (HLM 0.44)]. FS Date: 4/26/2017 9:46:51 AM

Waterside view: overview towards CMP sewer pipe

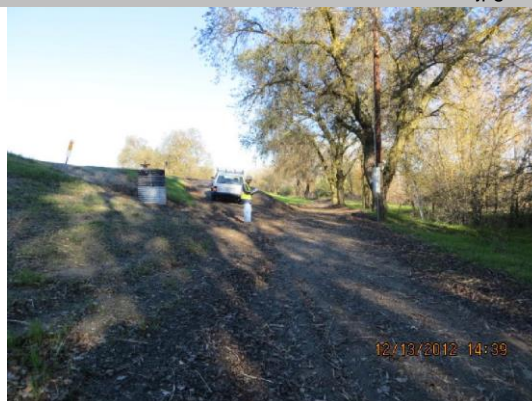
Photo 1 of 3 : UCIP_FA_2018_53399_46983.jpg

Comment Code					
Inspector Comment					
FS_ID:53399 DS_ID:17319 EP_NO: 9527 Repair Type: Urgent Crossing Status: Found UCIP Comments: 8/30/2018 WS vegetation completely overgrown towards walkway and pump so could not inspect. WS pipe end is nearly completely covered in debris, pipe cap appears either open or broken, LS erosion still present, and pipe end completely covered in debris so crossing remains Urgent (D. Sanoski - DWR UCIP).4/24/2017 LS slope damage is still present. No repairs have been made to this crossing yet. (DWR Sutter Yard- AFreitag)11/7/2016 No LS repairs have been made yet. (DWR Sutter Yard- AFreitag)6/6/2016 New flow meter installed on WS. Walkway to access the pump is overgrown with vegetation and not accessible. (DWR Sutter Yard - afreitag) 4/5/2016 Caved-in slope on landside (LS) not yet repaired. Leaky pipe marker gone. Per Bob Duffey (DWR FPIIB inspector), pipe will be replaced by owner next year. If not, will go to CVFPB enforcement. (DWR UCIP - kfazel)4/6/2015 Pipe leaks during times of High water. Slope damage still present. Needs a more detailed inspection to find the leak. (DWR Sutter Yard - afreitag)6/30/2014 Same as last inspection. (DWR Sutter Yard - afreitag)12/30/2013 Same as last inspection. (DWR Sutter Yard - afreitag)7/29/2013 Pipe does not appear to be abandoned. On the WS it appears that a smaller pipe was sleeved into the 18in. Pipe and then the difference capped and welded. Pump was not running at time of inspection but LS ditch near outlet was wet. LS slope damage and leaky pipe marker are still present. (DWR Sutter Yard - afreitag)12/13/2012 Abandoned and plugged/capped steel pipe on WS berm. DWR leaky pipe marker on LS (12-3). Slope failure on LS. Needs capping of LS steel pipe after detailed investigation. (DWR UCIP - pamatya) FIELD_STRUCT_DESC: 18-inch steel irrigation pipe through the levee, 12.5 feet below the crown. Gate valve on the waterside (WS). Vertical pump on the WS bank. Flow meter on the WS. (Automatic Board Order (ABO) issued as Permit No. 9527, 1974 - Butte Creek Farms) [Additional Reference(s): DWR Levee Log, 2002. USACE Sacramento O&M Manual 136, March 1960 (HLM 1.1)]. FS Date: 8/30/2018 12:42:00 PM

Waterside view: overview

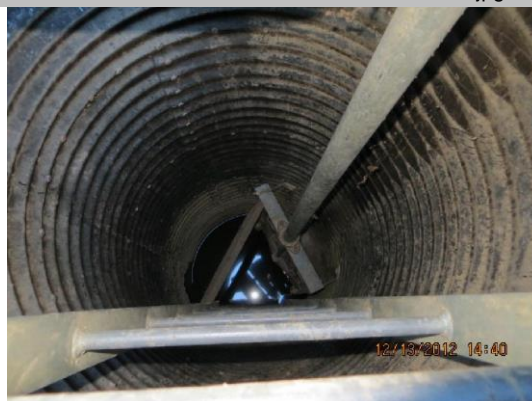
Photo 3 of 3 : UCIP_FA_2018_53399_46980.jpg

UCIP Comments: 8/30/2018 WS vegetation completely overgrown towards walkway and pump so could not inspect. WS pipe end is nearly completely covered in debris, pipe cap appears either open or broken, LS erosion still present, and pipe end completely covered in debris so crossing remains Urgent (D. Sanoski - DWR UCIP). 4/24/2017 LS slope damage is still present. No repairs have been made to this crossing yet. (DWR Sutter Yard- AFreitag) 11/7/2016 No LS repairs have been made yet. (DWR Sutter Yard- AFreitag) 6/6/2016 New flow meter installed on WS. Walkway to access the pump is overgrown with vegetation and not accessible. (DWR Sutter Yard - afreitag) 4/5/2016 Caved-in slope on landside (LS) not yet repaired. Leaky pipe marker gone. Per Bob Duffey (DWR FPIIB inspector), pipe will be replaced by owner next year. If not, will go to CVFPB enforcement. (DWR UCIP - kfazel) 4/6/2015 Pipe leaks during times of High water. Slope damage still present. Needs a more detailed inspection to find the leak. (DWR Sutter Yard - afreitag) 6/30/2014 Same as last inspection. (DWR Sutter Yard - afreitag) 12/30/2013 Same as last inspection. (DWR Sutter Yard - afreitag) 7/29/2013 Pipe does not appear to be abandoned. On the WS it appears that a smaller pipe was sleeved into the 18in. Pipe and then the difference capped and welded. Pump was not running at time of inspection but LS ditch near outlet was wet. LS slope damage and leaky pipe marker are still present. (DWR Sutter Yard - afreitag) 12/13/2012 Abandoned and plugged/capped steel pipe on WS berm. DWR leaky pipe marker on LS (12-3). Slope failure on LS. Needs capping of LS steel pipe after detailed investigation. (DWR UCIP - pamatya)

Waterside view: inside CMP riser

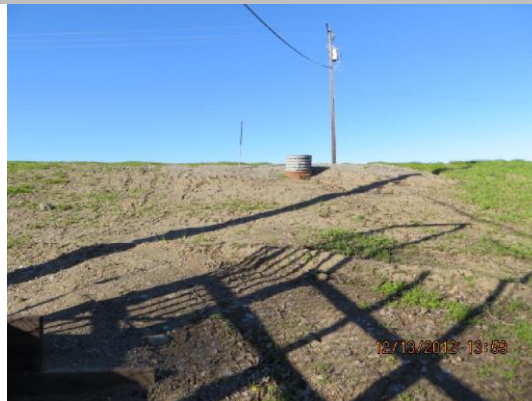
Photo 2 of 3 : UCIP_FA_2018_51656_46997.jpg

Comment Code					
Inspector Comment					
FS_ID:51656 DS_ID:17322 EP_NO: 9258 Repair Type: Non-Urgent Crossing Status: Found UCIP Comments: 4/24/2017 WS riser was still full of soil. Open 10" pipe on the WS bank was underwater during time of site visit. (DWR Sutter Yard- A Freitag)11/7/2016 WS riser still full of soil. No pump present and 10" pipe left opened on the WS. (DWR Sutter Yard- A Freitag)6/17/2016 Same as last inspection. 4/6/2015 CMP riser filled with silt/soil on WS. No other issues present.6/30/2014 Same as last inspection.12/30/2013 Same as last inspection.7/29/2013 Same as last inspection. FIELD_STRUCT_DESC: 10-inch asphalt coated steel irrigation pipe through the levee, 3.7 feet below the crown. Pump installed on the waterside (WS). (Permit No. 9258, 1974 - Harada). [Additional Reference(s): DWR Levee Log, 2002]. FS Date: 4/26/2017 10:15:33 AM

Waterside view: overview of CMP riser

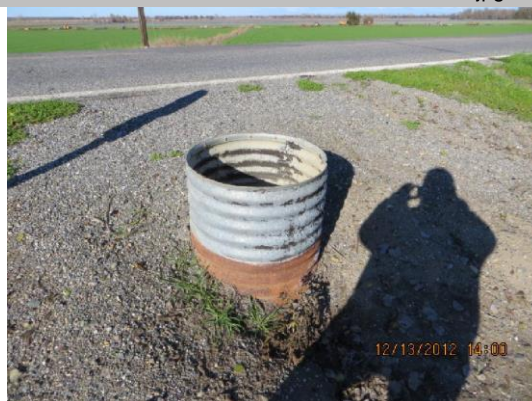
Photo 3 of 3 : UCIP_FA_2018_51656_46996.jpg

Comment Code						
Inspector Comment						
FS_ID:51656 DS_ID:17322 EP_NO: 9258 Repair Type: Non-Urgent Crossing Status: Found UCIP Comments: 4/24/2017 WS riser was still full of soil. Open 10" pipe on the WS bank was underwater during time of site visit. (DWR Sutter Yard- A Freitag)11/7/2016 WS riser still full of soil. No pump present and 10" pipe left opened on the WS. (DWR Sutter Yard- A Freitag)6/17/2016 Same as last inspection. 4/6/2015 CMP riser filled with silt/soil on WS. No other issues present.6/30/2014 Same as last inspection.12/30/2013 Same as last inspection.7/29/2013 Same as last inspection. FIELD_STRUCT_DESC: 10-inch asphalt coated steel irrigation pipe through the levee, 3.7 feet below the crown. Pump installed on the waterside (WS). (Permit No. 9258, 1974 - Harada). [Additional Reference(s): DWR Levee Log, 2002]. FS Date: 4/26/2017 10:15:33 AM

Waterside view: CMP riser

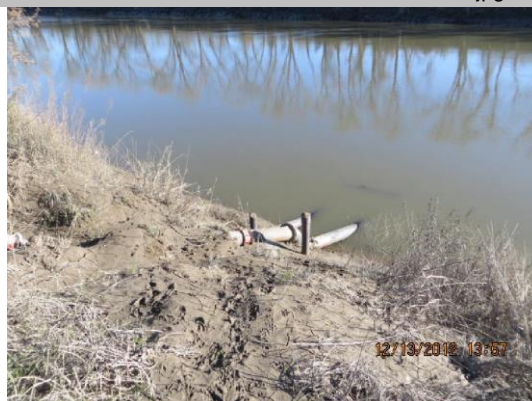
Photo 1 of 3 : UCIP_FA_2018_52947_47004.jpg

FS_ID:52947
DS_ID:17321
EP_NO: 9543
Repair Type: Non-Urgent
Crossing Status: Found
UCIP Comments: 8/30/2018 BRAND-NEW pipe and pump structure installed at this location. Pump in operation at time of inspection and no leaks were visible. Downgraded to Non-Urgent; will be further downgraded to No Action Needed when paperwork compliance with CVFPB is confirmed (D. Sanoski - DWR UCIP).4/24/2017
Abandoned and needs to be done so properly. Vegetation was to thick on the LS slope to see and sloughing or slope damage. (DWR Sutter Yard- AFreitag)11/7/2016 Abandoned. (DWR Sutter Yard- AFreitag)6/17/2016 Abandoned crossing. (DWR Sutter Yard - afreitag)4/5/2016 Appears abandoned and should be done so properly. LS levee slope has a slight but sudden drop (could be due to improper compaction). Dense vegetation on LS prevented visibility of sloughing or other damage to levee. Could not locate leaky pipe marker. Per Bryan Reniff of Sutter Yard, marker was previously installed due to a high water event, not leaky pipe. Appears repair work to levee performed but unclear of extent. Gate valve on WS is bent and damaged, appears abandoned. Crossing a good candidate for video inspection. (DWR UCIP - kfazel)4/6/2015 Sloughing LS slope and river bank. DWR marking for leaky pipe. (DWR Sutter Yard - afreitag)6/30/2014 Same as last inspection. (DWR Sutter Yard - afreitag)12/30/2013 Same as last inspection. (DWR Sutter Yard - afreitag)7/29/2013 Same as last inspection. (DWR Sutter Yard - afreitag)12/13/2012 Sloughing LS slope and river bank. DWR marking for leaky pipe. (DWR UCIP - pamatya)

Waterside view: pipe @river bank

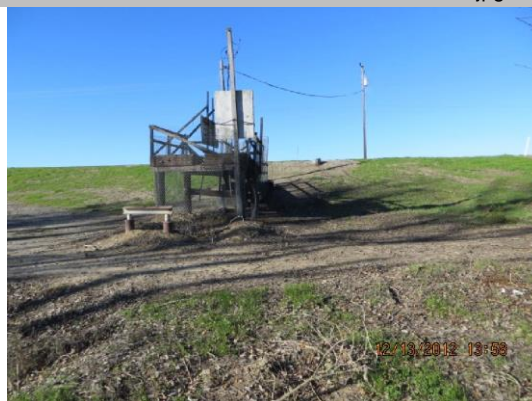
Photo 2 of 3 : UCIP_FA_2018_52947_47003.jpg

FS_ID:52947
DS_ID:17321
EP_NO: 9543
Repair Type: Non-Urgent
Crossing Status: Found
UCIP Comments: 8/30/2018 BRAND-NEW pipe and pump structure installed at this location. Pump in operation at time of inspection and no leaks were visible. Downgraded to Non-Urgent; will be further downgraded to No Action Needed when paperwork compliance with CVFPB is confirmed (D. Sanoski - DWR UCIP).4/24/2017
Abandoned and needs to be done so properly. Vegetation was to thick on the LS slope to see and sloughing or slope damage. (DWR Sutter Yard- AFreitag)11/7/2016 Abandoned. (DWR Sutter Yard- AFreitag)6/17/2016 Abandoned crossing. (DWR Sutter Yard - afreitag)4/5/2016 Appears abandoned and should be done so properly. LS levee slope has a slight but sudden drop (could be due to improper compaction). Dense vegetation on LS prevented visibility of sloughing or other damage to levee. Could not locate leaky pipe marker. Per Bryan Reniff of Sutter Yard, marker was previously installed due to a high water event, not leaky pipe. Appears repair work to levee performed but unclear of extent. Gate valve on WS is bent and damaged, appears abandoned. Crossing a good candidate for video inspection. (DWR UCIP - kfazel)4/6/2015 Sloughing LS slope and river bank. DWR marking for leaky pipe. (DWR Sutter Yard - afreitag)6/30/2014 Same as last inspection. (DWR Sutter Yard - afreitag)12/30/2013 Same as last inspection. (DWR Sutter Yard - afreitag)7/29/2013 Same as last inspection. (DWR Sutter Yard - afreitag)12/13/2012 Sloughing LS slope and river bank. DWR marking for leaky pipe. (DWR UCIP - pamatya)

Waterside view: abandoned pump station.

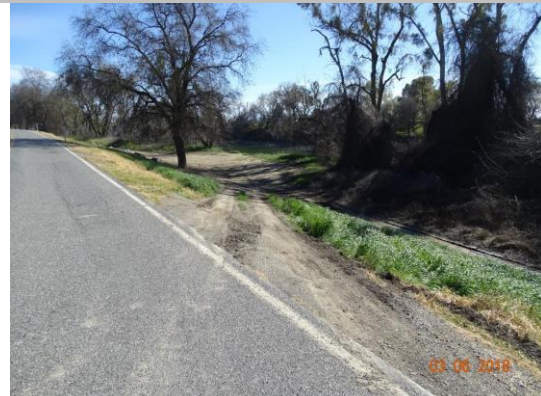
Photo 1 of 1 : FA_2018_ST0003_264_104_20180905_00024.jpg

LM Start	2.84	Rating **	M	Issue No.	104
LM End	2.84	Issue Type +	Ma	Location *	WS
Category	Earthen Levee			GPS Latitude/Longitude	
				Start	End
Item	Slope Stability			39.191162 °	39.191162 °
				-121.980365 °	-121.980365 °
DWR ID	DWR_ST0003_01_s_2018_104				
Comment Code					
S3 : Repair the levee slope damaged by vehicle traffic and prevent access where possible.					
Inspector Comment					
Repair the erosion along the water side slope caused by vehicle traffic.

View of the erosion along the waterside slope caused by vehicle traffic.

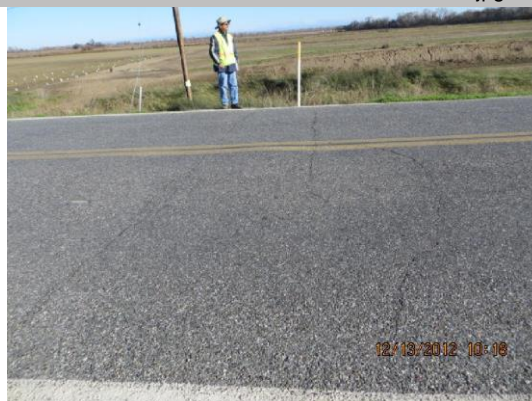
Photo 1 of 3 : UCIP_FA_2018_52952_47068.jpg

Crown view: transverse cracks on levee road.

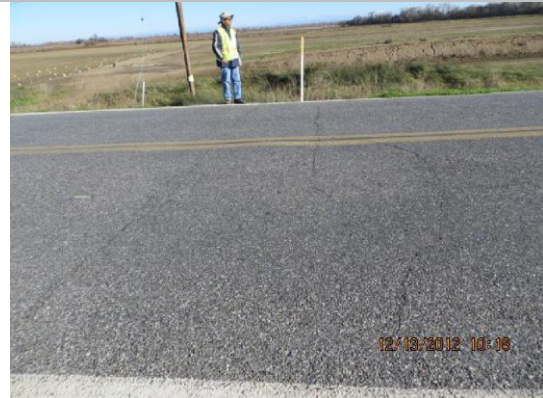
Photo 1 of 3 : UCIP_FA_2018_52953_47080.jpg

Crown view: cracks along pipe alignment (transverse crack)

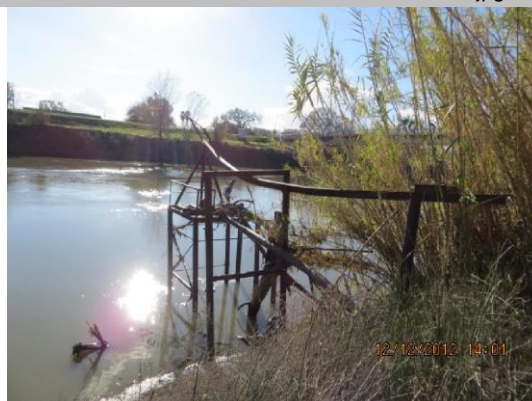
Photo 3 of 3 : UCIP_FA_2018_51683_47129.jpg

Waterside view: abandoned pump station.

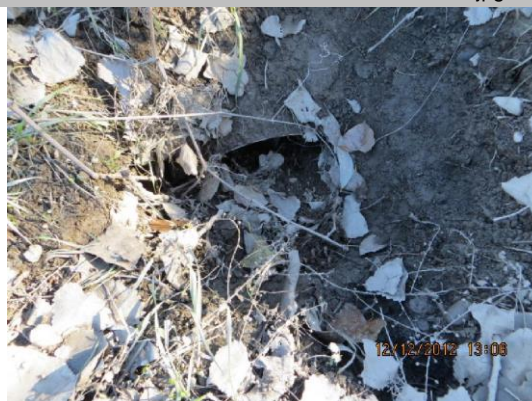
Photo 3 of 3 : UCIP_FA_2018_51688_47157.jpg

Waterside view: partially burried steel pipe

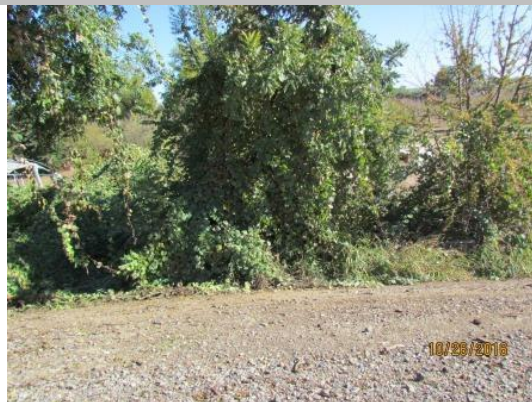
Photo 1 of 1 : FA_2018_ST0003_264_99_20180905_00022.jpg

View of the overgrown vegetation along the landside slope.

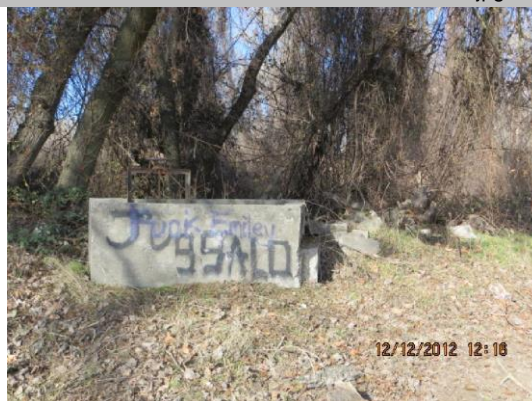
Photo 3 of 3 : UCIP_FA_2018_51694_47192.jpg

Waterside view: abandoned concrete surge box

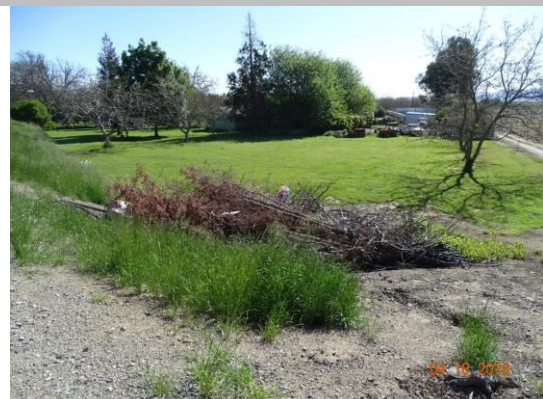
Photo 1 of 1 : FA_2018_ST0003_264_112_20180905_00026.jpg

View of the prunings along the landside toe.

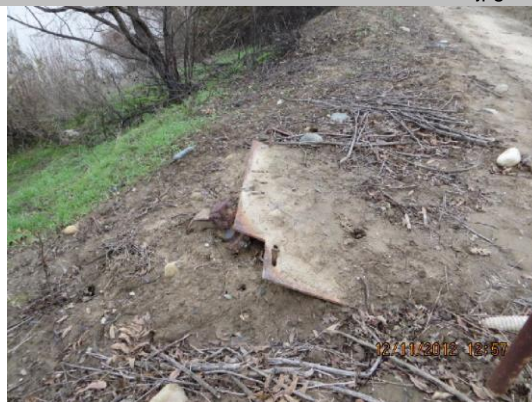
Photo 3 of 3 : UCIP_FA_2018_51735_47273.jpg

Waterside view: abandoned pump station.

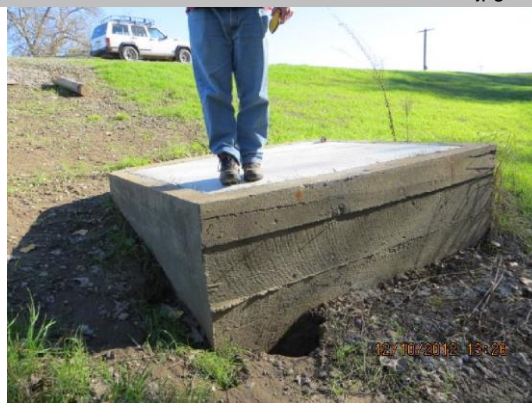
Photo 3 of 3 : UCIP_FA_2018_51753_47366.jpg

Waterside view: plugged concrete surge box
